Home Report

Single Survey

Property address	27 Shaw Road Prestwick KA9 2LW
Customer	Mr I Sloan & Mr T Nelson
Customer address	27 Shaw Road Prestwick KA9 2LW
Prepared by	Shepherd Chartered Surveyors
Date of inspection	12/03/2026

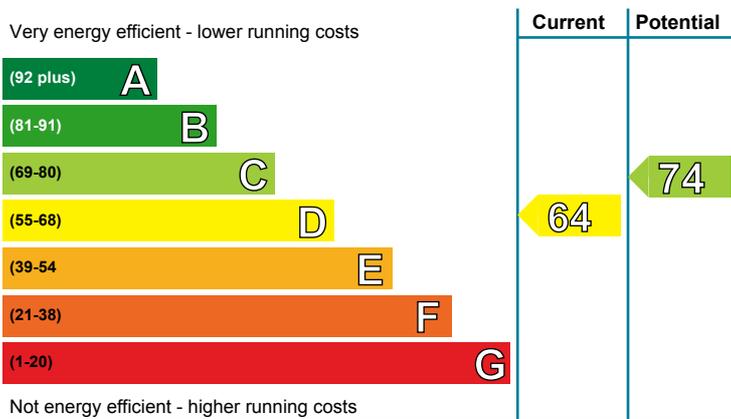
Energy Efficiency Rating

This graph shows the current efficiency of your home, taking into account both energy efficiency and fuel costs. The higher this rating, the lower your fuel bills are likely to be.

Your current rating is **band D (64)**. The average rating for EPCs in Scotland is **band D (61)**.

The potential rating shows the effect of undertaking all of the improvement measures listed within your recommendations report.

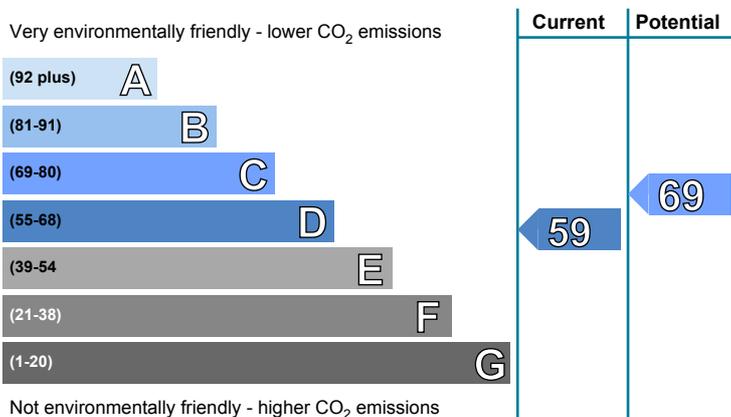
Environmental Impact (CO₂) Rating

This graph shows the effect of your home on the environment in terms of carbon dioxide (CO₂) emissions. The higher the rating, the less impact it has on the environment.
