Home Report

Single Survey

Property address	335 Kilmarnock Road Glasgow G43 2DS
-------------------------	---

PART 1 - GENERAL

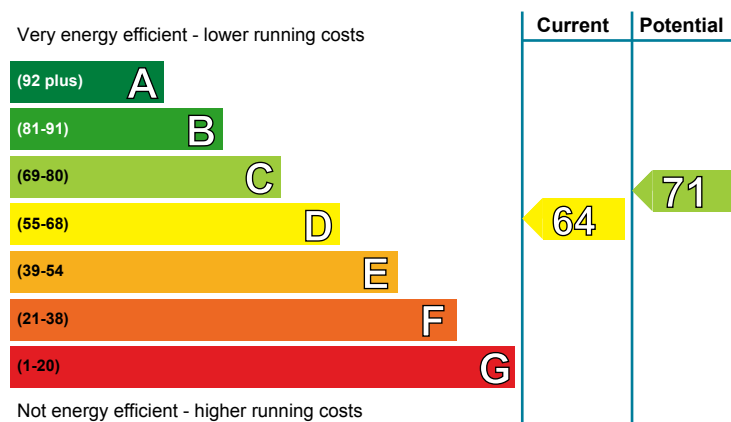
Energy Efficiency Rating

This graph shows the current efficiency of your home, taking into account both energy efficiency and fuel costs. The higher this rating, the lower your fuel bills are likely to be.

Your current rating is **band D (64)**. The average rating for EPCs in Scotland is **band D (61)**.

The potential rating shows the effect of undertaking all of the improvement measures listed within your recommendations report.

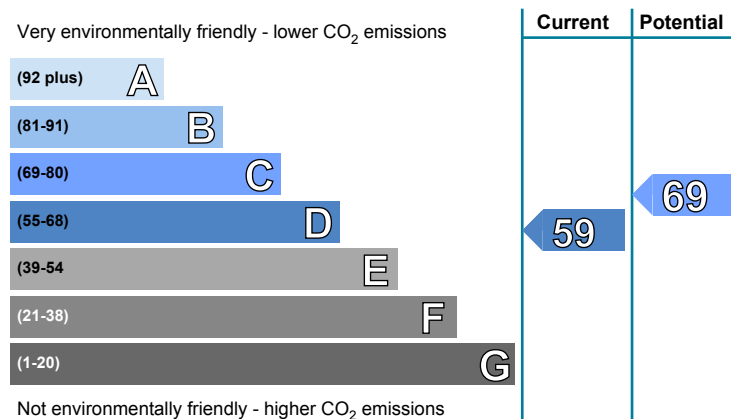
Environmental Impact (CO₂) Rating

This graph shows the effect of your home on the environment in terms of carbon dioxide (CO₂) emissions. The higher the rating, the less impact it has on the environment.
