Home Report

Single Survey

Property address	12 Tain Avenue Bishopton PA7 5GF
Customer	Mr Richard & Mrs Morgan Graham
Customer address	12 Tain Avenue Bishopton PA7 5GF
Prepared by	Shepherd Chartered Surveyors
Date of inspection	17/04/2026

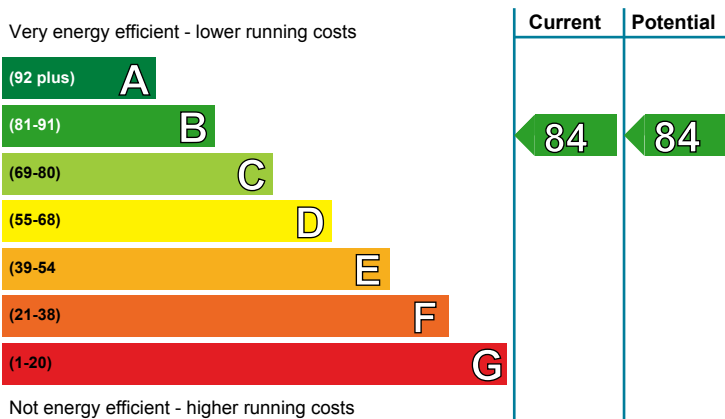
Energy Efficiency Rating

This graph shows the current efficiency of your home, taking into account both energy efficiency and fuel costs. The higher this rating, the lower your fuel bills are likely to be.

Your current rating is **band B (84)**. The average rating for EPCs in Scotland is **band D (61)**.

The potential rating shows the effect of undertaking all of the improvement measures listed within your recommendations report.
