YOUR ONESURVEY
HOME REPORT

9 Brent Crescent
Houston
Johnstone
PA6 7JE

SINGLE SURVEY

Single Survey

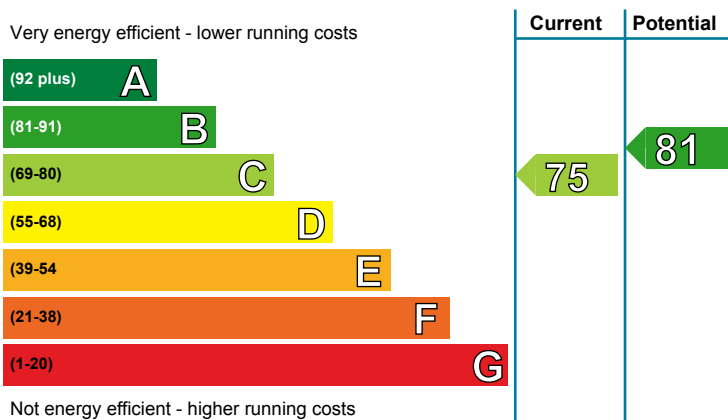
Energy Efficiency Rating

This graph shows the current efficiency of your home, taking into account both energy efficiency and fuel costs. The higher this rating, the lower your fuel bills are likely to be.

Your current rating is **band C (75)**. The average rating for EPCs in Scotland is **band D (61)**.

The potential rating shows the effect of undertaking all of the improvement measures listed within your recommendations report.

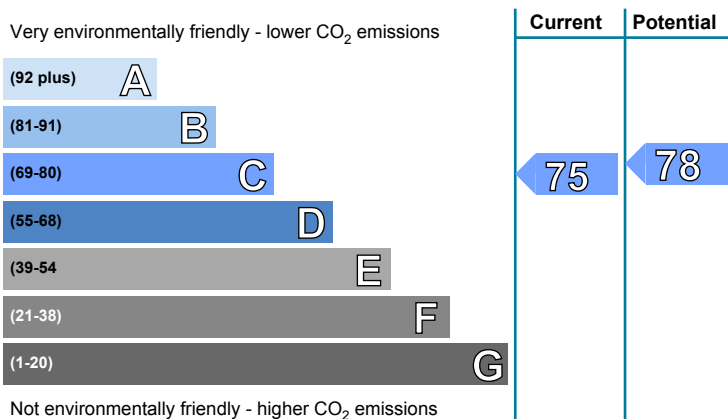
Environmental Impact (CO₂) Rating

This graph shows the effect of your home on the environment in terms of carbon dioxide (CO₂) emissions. The higher the rating, the less impact it has on the environment.
