YOUR ONESURVEY
HOME REPORT

53 Heathcliff Drive
East Kilbride
Glasgow
G75 8ZA

SINGLE SURVEY

Single Survey

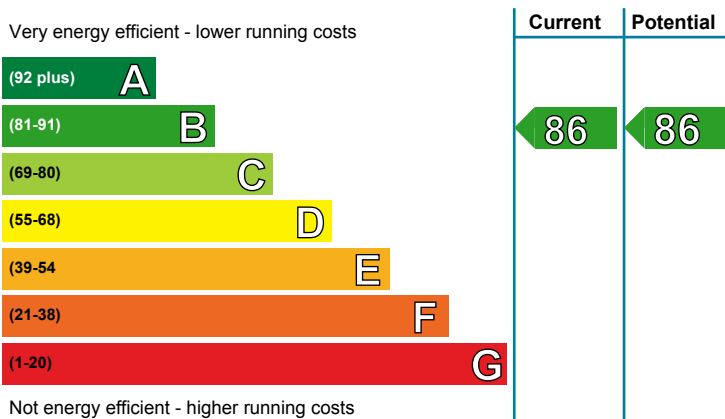
Energy Efficiency Rating

This graph shows the current efficiency of your home, taking into account both energy efficiency and fuel costs. The higher this rating, the lower your fuel bills are likely to be.

Your current rating is **band B (86)**. The average rating for EPCs in Scotland is **band D (61)**.

The potential rating shows the effect of undertaking all of the improvement measures listed within your recommendations report.
