Home Report

Scottish Single Survey

Property address	Ashcraig Shore Road Skelmorlie PA17 5HB
Customer	Nicola Fox
Customer address	Ashcraig Shore Road Skelmorlie PA17 5HB
Prepared by	Shepherd Chartered Surveyors
Date of inspection	24/04/2026

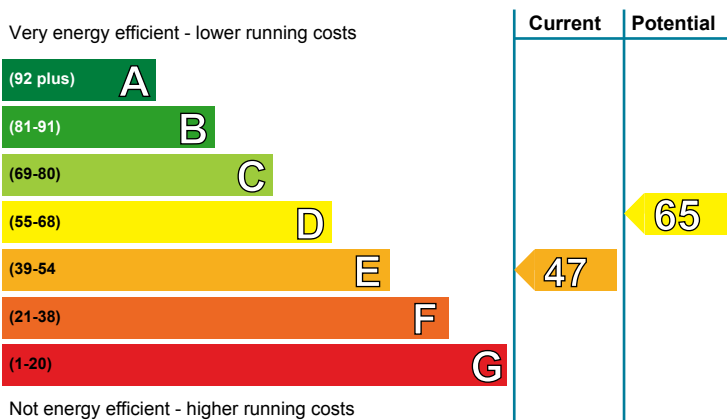
Energy Efficiency Rating

This graph shows the current efficiency of your home, taking into account both energy efficiency and fuel costs. The higher this rating, the lower your fuel bills are likely to be.

Your current rating is **band E (47)**. The average rating for EPCs in Scotland is **band D (61)**.

The potential rating shows the effect of undertaking all of the improvement measures listed within your recommendations report.

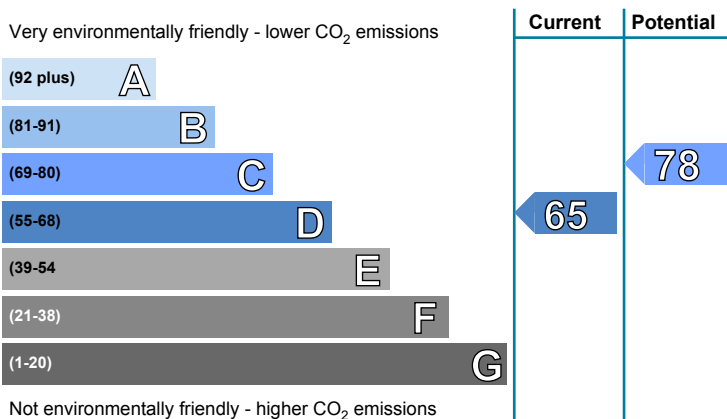
Environmental Impact (CO₂) Rating

This graph shows the effect of your home on the environment in terms of carbon dioxide (CO₂) emissions. The higher the rating, the less impact it has on the environment.
