# Home Report

# Single Survey

<b>Property address</b>	3/2 275 Crow Road Glasgow G11 7BG
<b>Customer</b>	Katherine Fraser & Hamish Docherty
<b>Customer address</b>	3/2 275 Crow Road Glasgow G11 7BG
<b>Prepared by</b>	Shepherd Chartered Surveyors
<b>Date of inspection</b>	11/06/2026

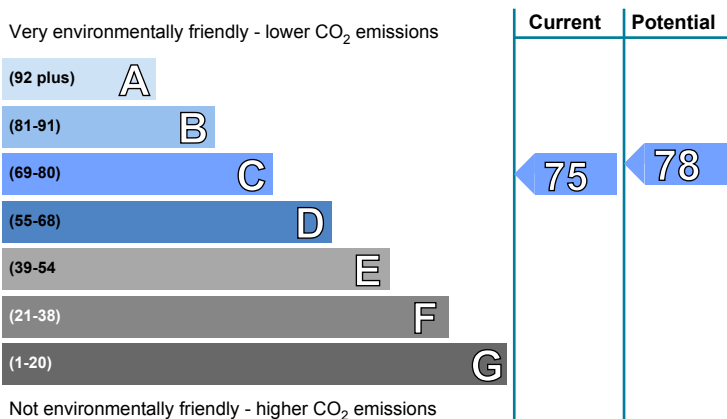
## Environmental Impact (CO<sub>2</sub>) Rating

This graph shows the effect of your home on the environment in terms of carbon dioxide (CO<sub>2</sub>) emissions. The higher the rating, the less impact it has on the environment.
