Home Report

Scottish Single Survey

Property address	43 Crandleyhill Road Prestwick KA9 2BE
-------------------------	--

Prepared by	Shepherd Chartered Surveyors
--------------------	------------------------------

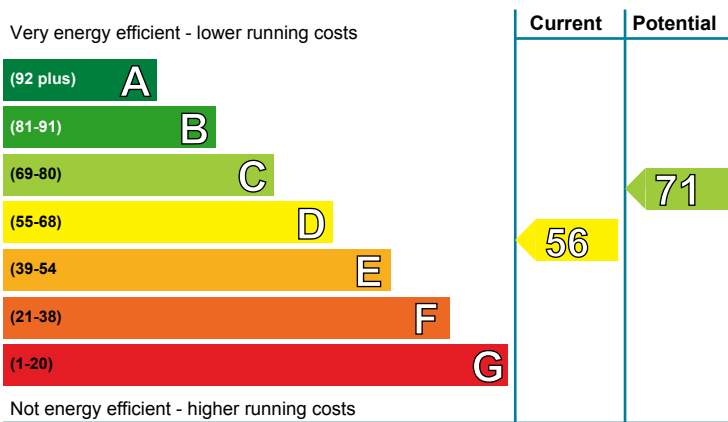
Energy Efficiency Rating

This graph shows the current efficiency of your home, taking into account both energy efficiency and fuel costs. The higher this rating, the lower your fuel bills are likely to be.

Your current rating is **band D (56)**. The average rating for EPCs in Scotland is **band D (61)**.

The potential rating shows the effect of undertaking all of the improvement measures listed within your recommendations report.

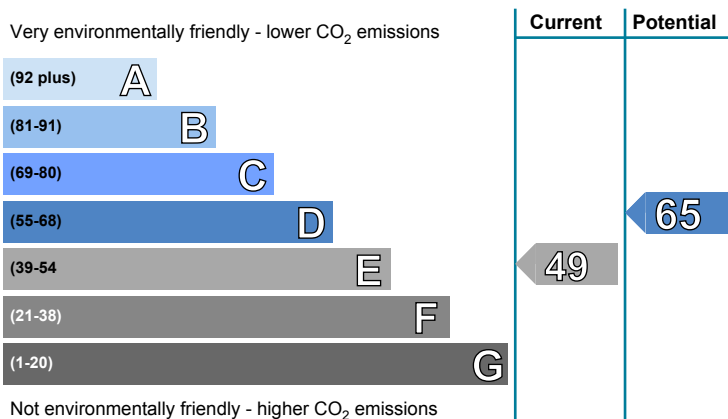
Environmental Impact (CO₂) Rating

This graph shows the effect of your home on the environment in terms of carbon dioxide (CO₂) emissions. The higher the rating, the less impact it has on the environment.
