Home Report

Scottish Single Survey

Single Survey

Property address	7 Deepdene Road Bearsden Glasgow G61 1NU
-------------------------	---

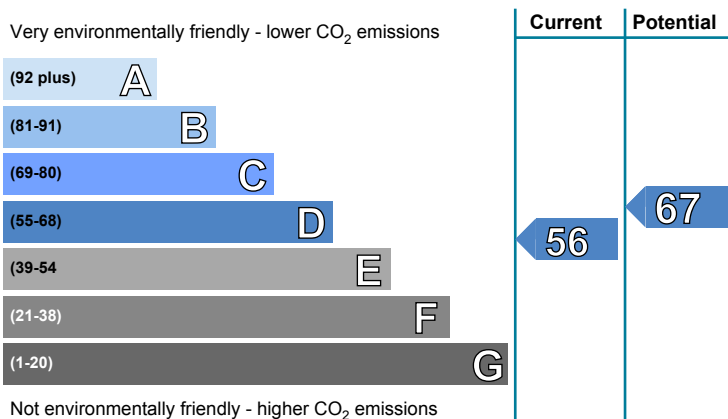
Environmental Impact (CO₂) Rating

This graph shows the effect of your home on the environment in terms of carbon dioxide (CO₂) emissions. The higher the rating, the less impact it has on the environment.
