# Home Report

# Scottish Single Survey

<b>Property address</b>	0/2 9 Prospecthill Grove Glasgow G42 9LG
<b>Customer</b>	Sarah Curran
<b>Customer address</b>	0/2 9 Prospecthill Grove Glasgow G42 9LG
<b>Prepared by</b>	Shepherd Chartered Surveyors
<b>Date of inspection</b>	27/05/2026

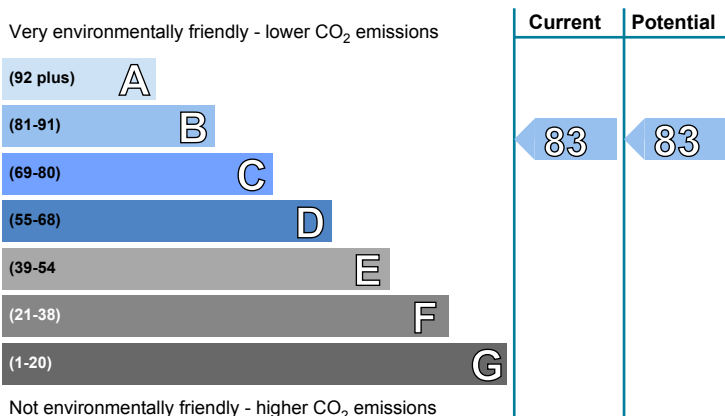
## Environmental Impact (CO<sub>2</sub>) Rating

This graph shows the effect of your home on the environment in terms of carbon dioxide (CO<sub>2</sub>) emissions. The higher the rating, the less impact it has on the environment.
