2/1 9,
Kirkland Street,
GLASGOW,
G20 6SY

Home Report

Single Survey

Survey Report on:

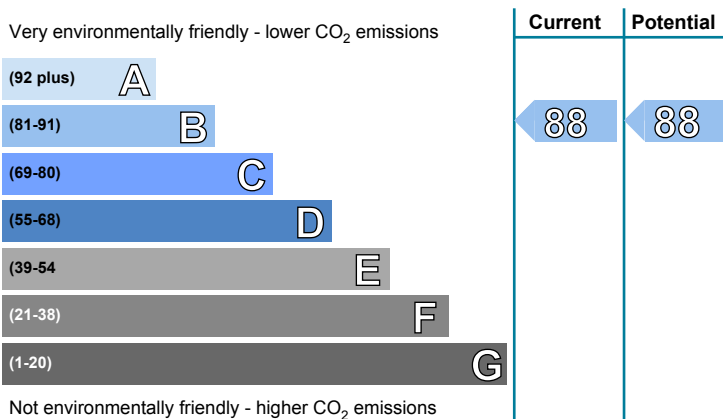
Environmental Impact (CO₂) Rating

This graph shows the effect of your home on the environment in terms of carbon dioxide (CO₂) emissions. The higher the rating, the less impact it has on the environment.
