20 Armour Road,
IRVINE,
KA11 2HF

Home Report

Single Survey

Property Address	20 Armour Road, IRVINE, KA11 2HF
Reference	1598904
Customer Name	Mr & Mrs Davis
Date of Inspection	25th May 2026
Surveyor's name, qualifications and office	Ross Cooper , BSc (Hons) AssocRICS DM Hall LLP Chartered Surveyors Eldo House, Monkton Road, Prestwick, KA9 2PB Tel: 01292 286974 email: ayrshireresidential@dmhall.co.uk
Prepared By	DM Hall LLP

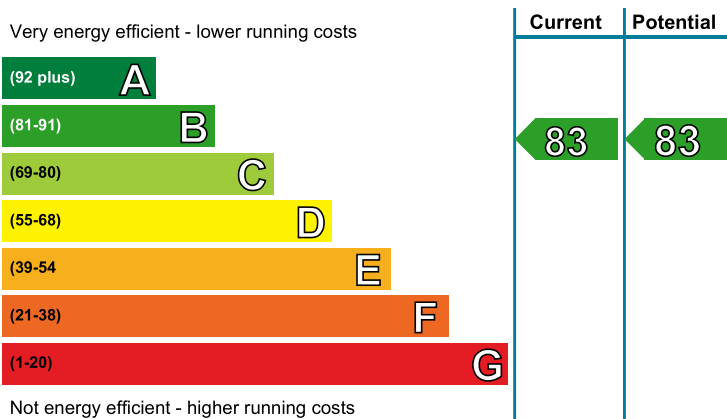
Energy Efficiency Rating

This graph shows the current efficiency of your home, taking into account both energy efficiency and fuel costs. The higher this rating, the lower your fuel bills are likely to be.

Your current rating is **band B (83)**. The average rating for EPCs in Scotland is **band D (61)**.

The potential rating shows the effect of undertaking all of the improvement measures listed within your recommendations report.

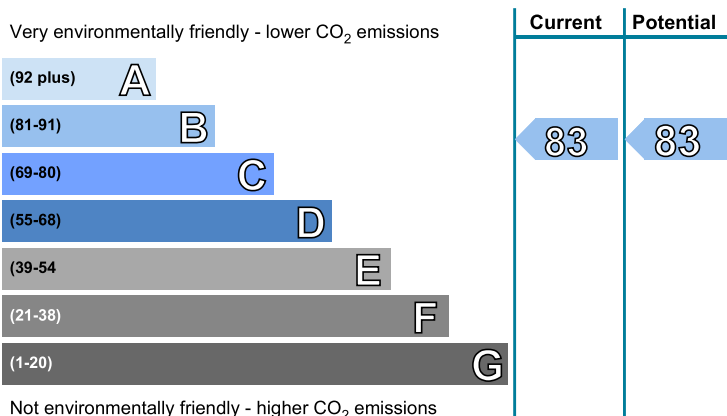
Environmental Impact (CO₂) Rating

This graph shows the effect of your home on the environment in terms of carbon dioxide (CO₂) emissions. The higher the rating, the less impact it has on the environment.
