Home Report

Scottish Single Survey

Property address	30 Norfield Drive Glasgow G44 4UD
Customer	MR IAN MCCONNELL
Customer address	30 Norfield Drive Glasgow G44 4UD
Prepared by	Shepherd Chartered Surveyors
Date of inspection	11/05/2026

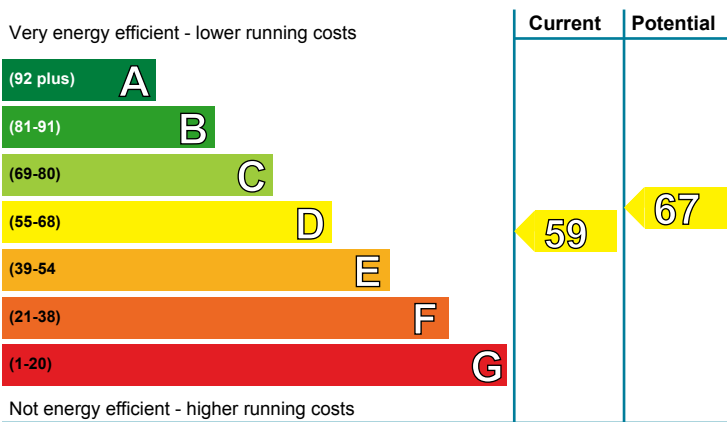
Energy Efficiency Rating

This graph shows the current efficiency of your home, taking into account both energy efficiency and fuel costs. The higher this rating, the lower your fuel bills are likely to be.

Your current rating is **band D (59)**. The average rating for EPCs in Scotland is **band D (61)**.

The potential rating shows the effect of undertaking all of the improvement measures listed within your recommendations report.

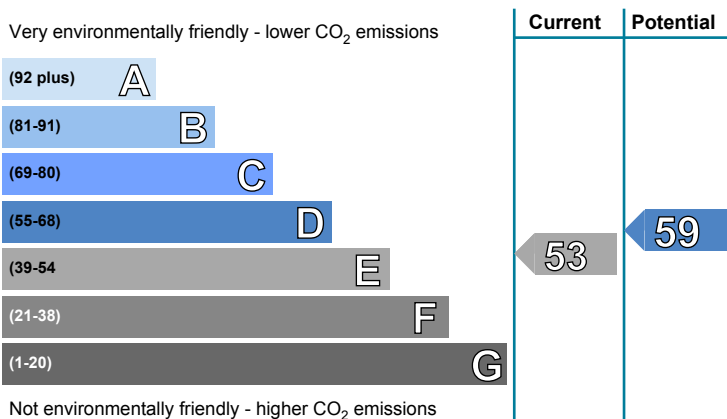
Environmental Impact (CO₂) Rating

This graph shows the effect of your home on the environment in terms of carbon dioxide (CO₂) emissions. The higher the rating, the less impact it has on the environment.
