Home Report

Single Survey

Property address	4 Eglinton Crescent Troon KA10 6LQ
-------------------------	------------------------------------------

Prepared by	Shepherd Chartered Surveyors
--------------------	------------------------------

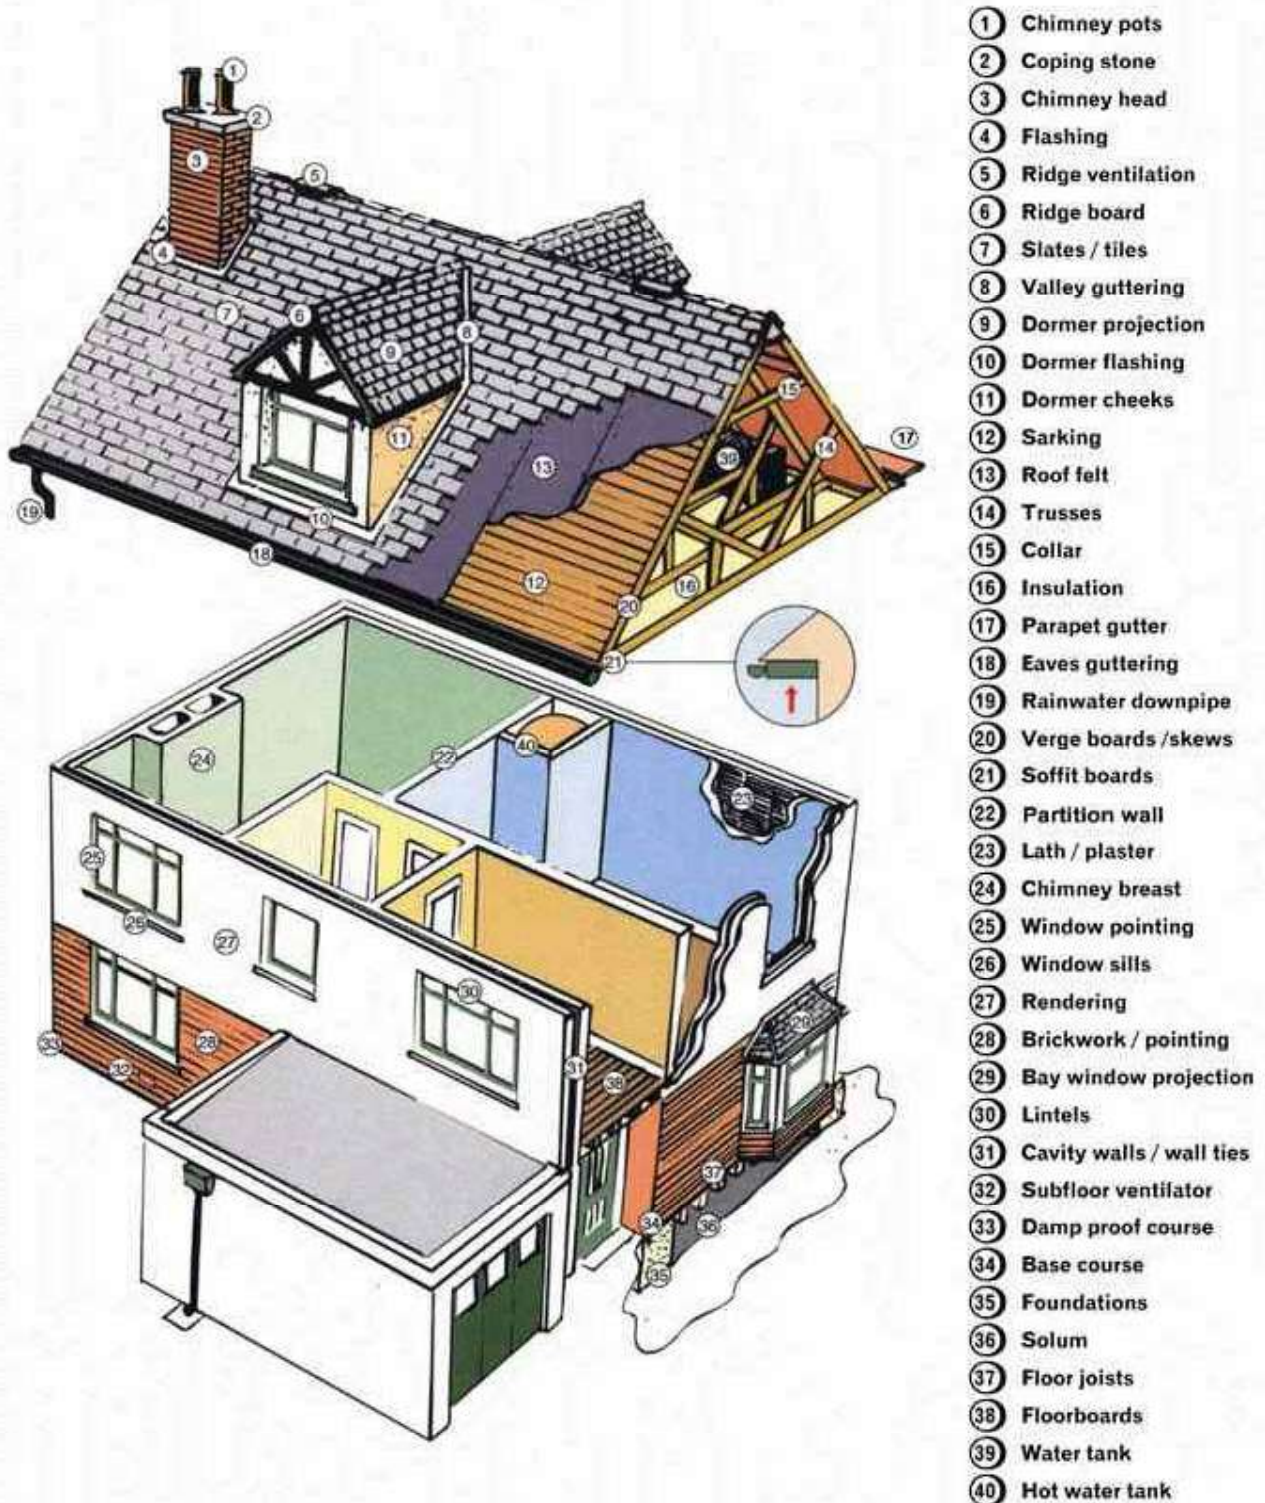
Sectional Diagram showing elements of a typical house

Reference may be made in this report to some or all of the above component parts of the property. This diagram may assist you in locating and understanding these items.

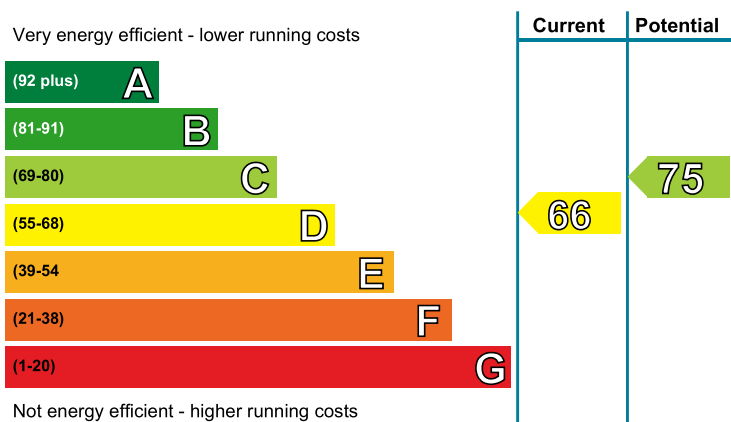
Energy Efficiency Rating

This graph shows the current efficiency of your home, taking into account both energy efficiency and fuel costs. The higher this rating, the lower your fuel bills are likely to be.

Your current rating is **band D (66)**. The average rating for EPCs in Scotland is **band D (61)**.

The potential rating shows the effect of undertaking all of the improvement measures listed within your recommendations report.

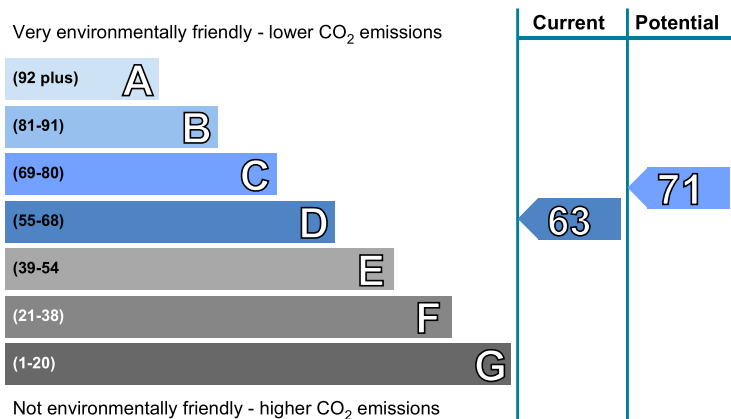
Environmental Impact (CO₂) Rating

This graph shows the effect of your home on the environment in terms of carbon dioxide (CO₂) emissions. The higher the rating, the less impact it has on the environment.
