Home Report

Scottish Single Survey

Property address	7 Beech Avenue Newton Mearns Glasgow G77 5PR
Customer	Anna Taylor
Customer address	7 Beech Avenue Newton Mearns Glasgow G77 5PR
Prepared by	Shepherd Chartered Surveyors
Date of inspection	28/05/2026

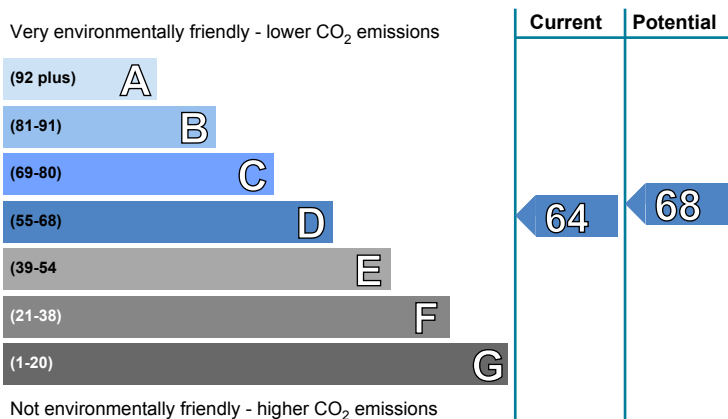
Environmental Impact (CO₂) Rating

This graph shows the effect of your home on the environment in terms of carbon dioxide (CO₂) emissions. The higher the rating, the less impact it has on the environment.
