HOME
report

SINGLE SURVEY
ENERGY REPORT
PROPERTY QUESTIONNAIRE
VALUATION REPORT

Property Address	Flat 2/2, 23 Napiershall Street, Glasgow, G20 6EZ
Customer	Mr E Smith
Date of Inspection	07/04/2026
Prepared by	Brett G McMillan Harvey Donaldson & Gibson Chartered Surveyors

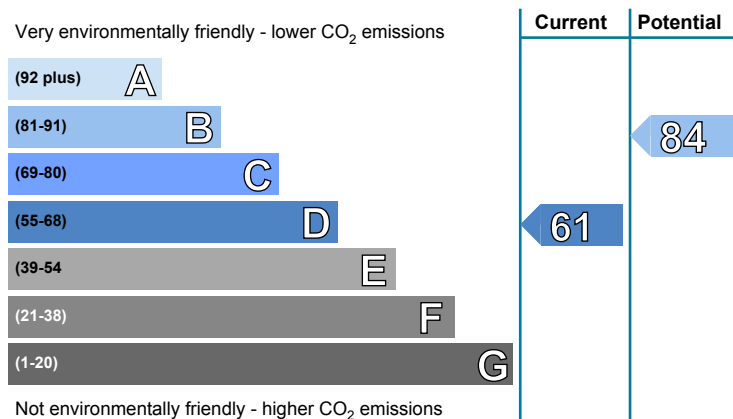
Environmental Impact (CO₂) Rating

This graph shows the effect of your home on the environment in terms of carbon dioxide (CO₂) emissions. The higher the rating, the less impact it has on the environment.
