YOUR ONESURVEY
HOME REPORT

4 Ranfurly Road
Bridge of Weir
PA11 3ES

SINGLE SURVEY

Surveyor Reference	PD/9871
Customer	David Girdwood
Selling address	4 Ranfurly Road Bridge of Weir PA11 3ES
Date of Inspection	13/05/2026
Prepared by	Ross Carpenter, MRICS Bsc (hons) Paisley - Allied Surveyors Scotland Ltd

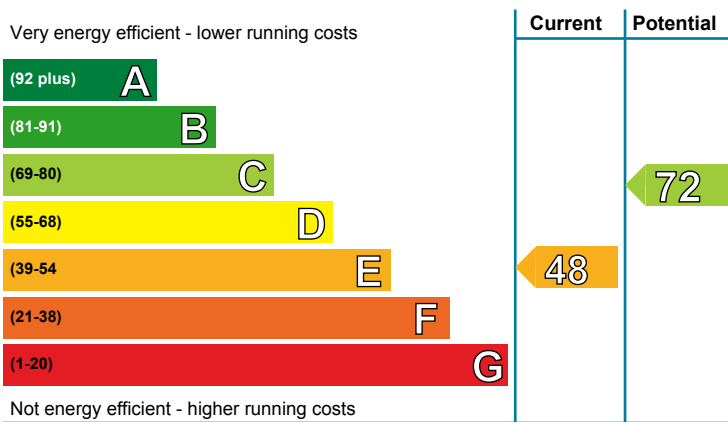
Energy Efficiency Rating

This graph shows the current efficiency of your home, taking into account both energy efficiency and fuel costs. The higher this rating, the lower your fuel bills are likely to be.

Your current rating is **band E (48)**. The average rating for EPCs in Scotland is **band D (61)**.

The potential rating shows the effect of undertaking all of the improvement measures listed within your recommendations report.
