YOUR ONESURVEY
HOME REPORT

Glenburnie
Pinmore
Girvan
KA26 0TW

SINGLE SURVEY

Single Survey

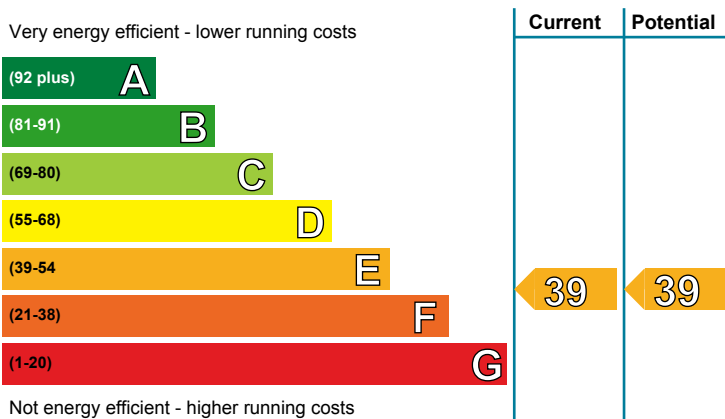
Energy Efficiency Rating

This graph shows the current efficiency of your home, taking into account both energy efficiency and fuel costs. The higher this rating, the lower your fuel bills are likely to be.

Your current rating is **band E (39)**. The average rating for EPCs in Scotland is **band D (61)**.

The potential rating shows the effect of undertaking all of the improvement measures listed within your recommendations report.

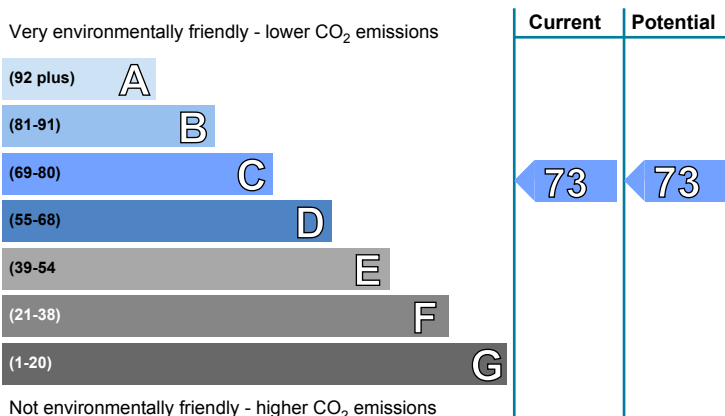
Environmental Impact (CO₂) Rating

This graph shows the effect of your home on the environment in terms of carbon dioxide (CO₂) emissions. The higher the rating, the less impact it has on the environment.
