YOUR ONESURVEY  
**HOME REPORT**

T/R  
1 Lyle Buildings  
Lochwinnoch Road  
Kilmacollm, PA13 4LE

# SINGLE SURVEY

# Single Survey

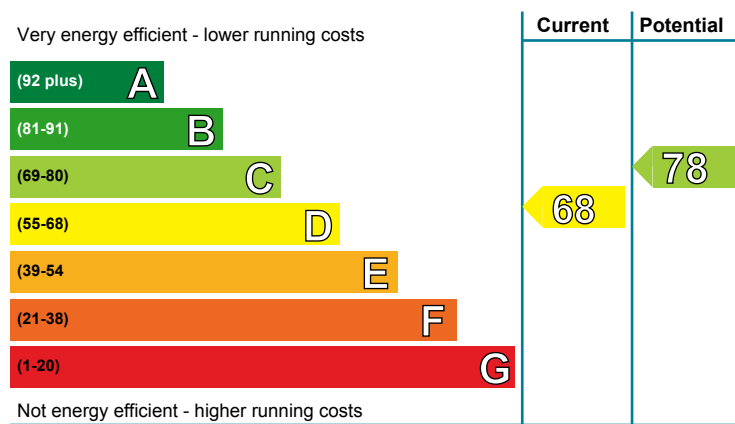
## Energy Efficiency Rating

This graph shows the current efficiency of your home, taking into account both energy efficiency and fuel costs. The higher this rating, the lower your fuel bills are likely to be.

Your current rating is **band D (68)**. The average rating for EPCs in Scotland is **band D (61)**.

The potential rating shows the effect of undertaking all of the improvement measures listed within your recommendations report.

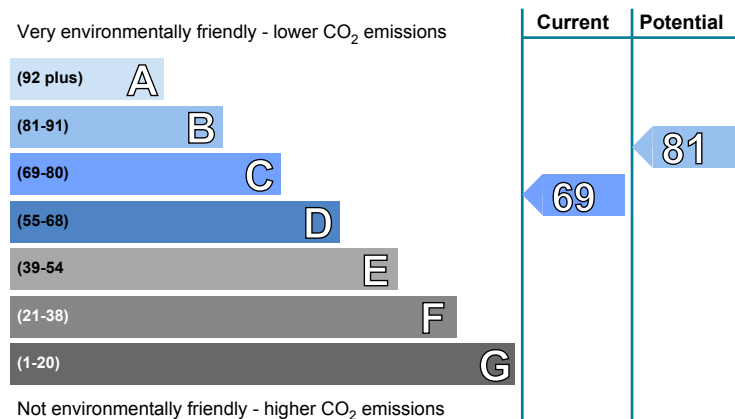
## Environmental Impact (CO<sub>2</sub>) Rating

This graph shows the effect of your home on the environment in terms of carbon dioxide (CO<sub>2</sub>) emissions. The higher the rating, the less impact it has on the environment.
