YOUR ONESURVEY
HOME REPORT

61 Balcarres Avenue
Glasgow
G12 0QE

SINGLE SURVEY

Single Survey

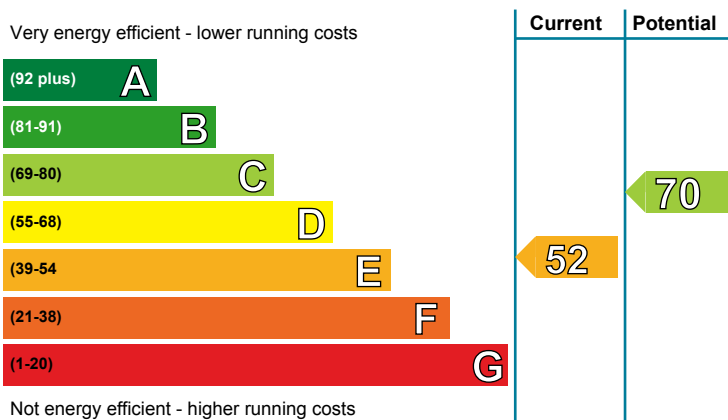
Energy Efficiency Rating

This graph shows the current efficiency of your home, taking into account both energy efficiency and fuel costs. The higher this rating, the lower your fuel bills are likely to be.

Your current rating is **band E (52)**. The average rating for EPCs in Scotland is **band D (61)**.

The potential rating shows the effect of undertaking all of the improvement measures listed within your recommendations report.

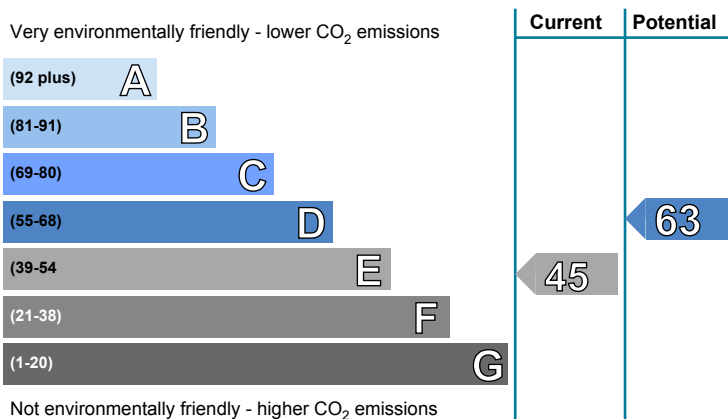
Environmental Impact (CO₂) Rating

This graph shows the effect of your home on the environment in terms of carbon dioxide (CO₂) emissions. The higher the rating, the less impact it has on the environment.
