YOUR ONESURVEY
HOME REPORT

9 Bruce Road
Bishopton
PA7 5EY

SINGLE SURVEY

Single Survey

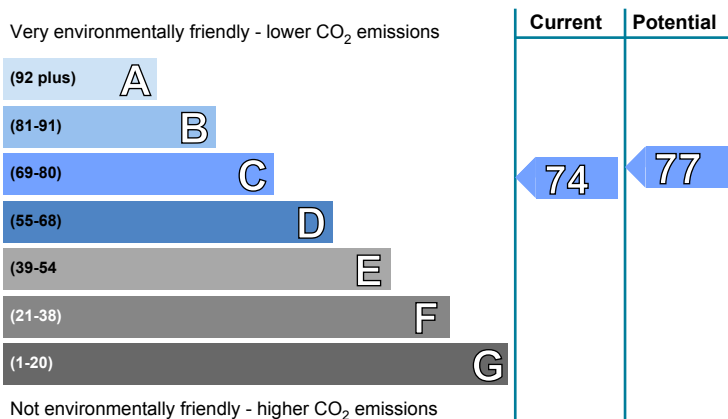
Environmental Impact (CO₂) Rating

This graph shows the effect of your home on the environment in terms of carbon dioxide (CO₂) emissions. The higher the rating, the less impact it has on the environment.
