YOUR ONESURVEY
HOME REPORT

34 Lennox Avenue
Scotstoun
Glasgow
G14 9HG

SINGLE SURVEY

Single Survey

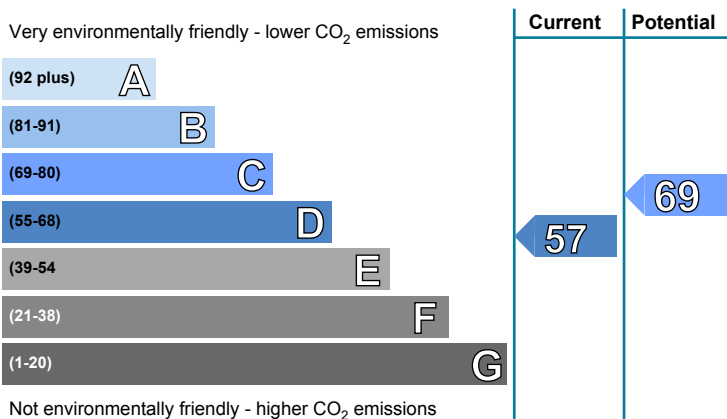
Environmental Impact (CO₂) Rating

This graph shows the effect of your home on the environment in terms of carbon dioxide (CO₂) emissions. The higher the rating, the less impact it has on the environment.
