Home Report

Scottish Single Survey

Property address	5 Bruce Crescent Ayr KA7 1JH
Customer	Ms F Robertson
Customer address	5 Bruce Crescent Ayr KA7 1JH
Prepared by	Shepherd Chartered Surveyors
Date of inspection	19/05/2026

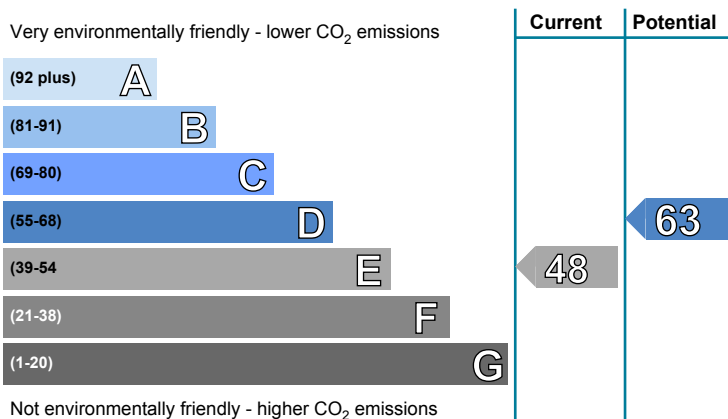
Environmental Impact (CO₂) Rating

This graph shows the effect of your home on the environment in terms of carbon dioxide (CO₂) emissions. The higher the rating, the less impact it has on the environment.
