# Home Report

# Scottish Single Survey

# Single Survey

| Property address | 13 Duart Avenue<br>Prestwick<br>KA9 1NA |

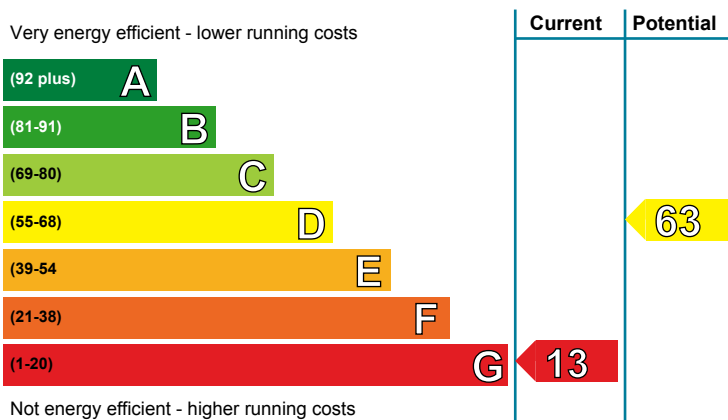
## Energy Efficiency Rating

This graph shows the current efficiency of your home, taking into account both energy efficiency and fuel costs. The higher this rating, the lower your fuel bills are likely to be.

Your current rating is **band G (13)**. The average rating for EPCs in Scotland is **band D (61)**.

The potential rating shows the effect of undertaking all of the improvement measures listed within your recommendations report.
