Home Report

Scottish Single Survey

Single Survey

Property address	Kilmannan Farm Blanefield Glasgow G63 9AX
Customer	Catherine Farrell
Customer address	Kilmannan Farm Blanefield Glasgow G63 9AX
Prepared by	Shepherd Chartered Surveyors
Date of inspection	20/05/2026

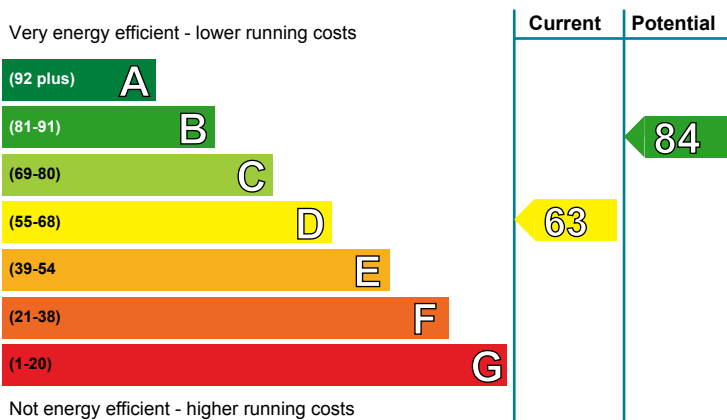
Energy Efficiency Rating

This graph shows the current efficiency of your home, taking into account both energy efficiency and fuel costs. The higher this rating, the lower your fuel bills are likely to be.

Your current rating is **band D (63)**. The average rating for EPCs in Scotland is **band D (61)**.

The potential rating shows the effect of undertaking all of the improvement measures listed within your recommendations report.

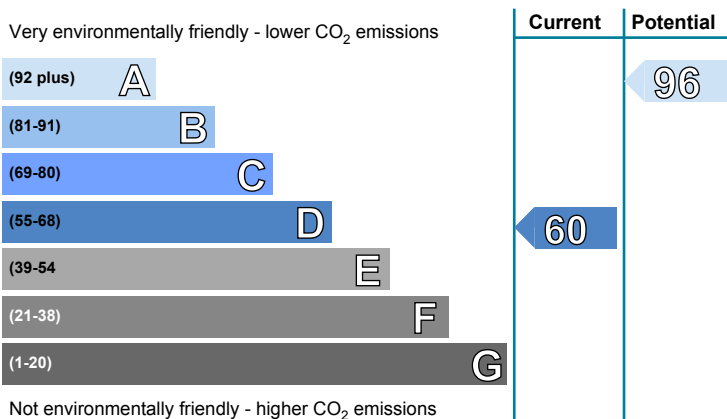
Environmental Impact (CO₂) Rating

This graph shows the effect of your home on the environment in terms of carbon dioxide (CO₂) emissions. The higher the rating, the less impact it has on the environment.
