YOUR ONESURVEY
HOME REPORT

0/1
13 Tassie Street
Glasgow
G41 3QB

SINGLE SURVEY

Single Survey

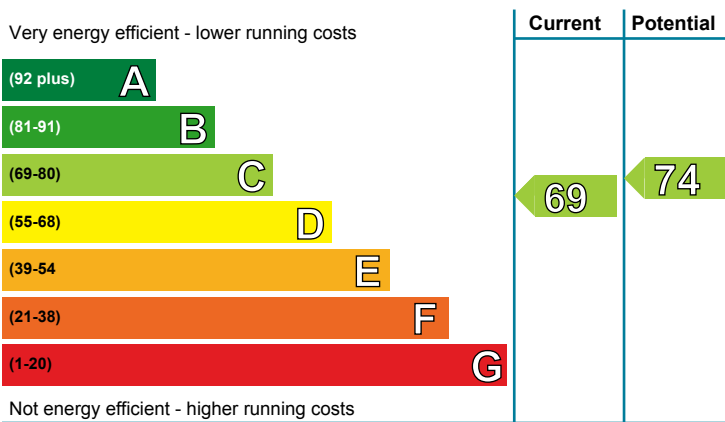
Energy Efficiency Rating

This graph shows the current efficiency of your home, taking into account both energy efficiency and fuel costs. The higher this rating, the lower your fuel bills are likely to be.

Your current rating is **band C (69)**. The average rating for EPCs in Scotland is **band D (61)**.

The potential rating shows the effect of undertaking all of the improvement measures listed within your recommendations report.

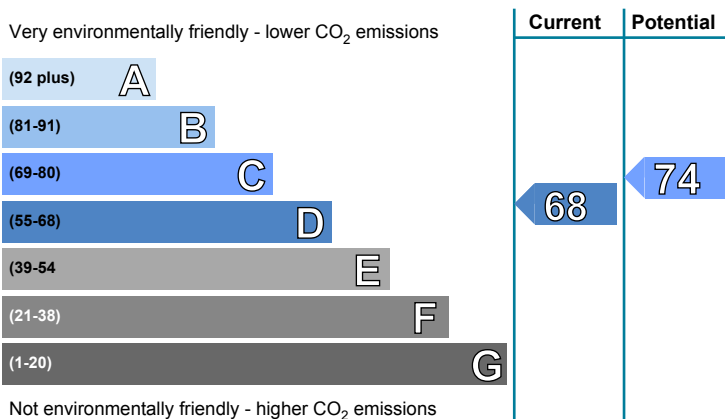
Environmental Impact (CO₂) Rating

This graph shows the effect of your home on the environment in terms of carbon dioxide (CO₂) emissions. The higher the rating, the less impact it has on the environment.
