Home Report

Scottish Single Survey

Property address	Flat 0/7 80 Inverlair Avenue Glasgow G43 2BD
-------------------------	---

Prepared by	Shepherd Chartered Surveyors
--------------------	------------------------------

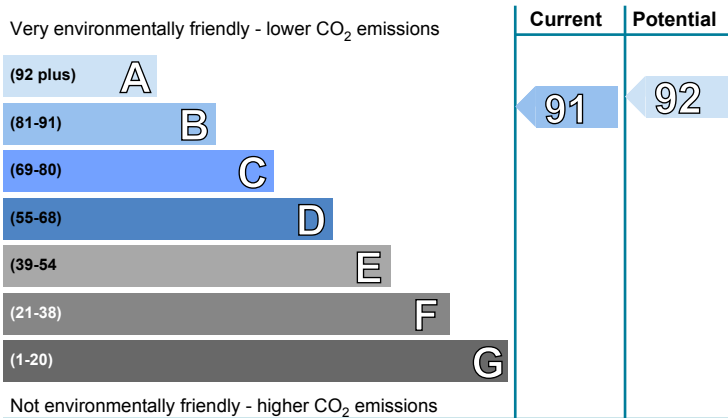
Environmental Impact (CO₂) Rating

This graph shows the effect of your home on the environment in terms of carbon dioxide (CO₂) emissions. The higher the rating, the less impact it has on the environment.
