Home Report

Scottish Single Survey

Property address	Flat 1/1 312 Albert Drive Glasgow G41 5RS
Customer	Lesley Cummings
Customer address	Flat 1/1 312 Albert Drive Glasgow G41 5RS
Prepared by	Shepherd Chartered Surveyors
Date of inspection	02/06/2026

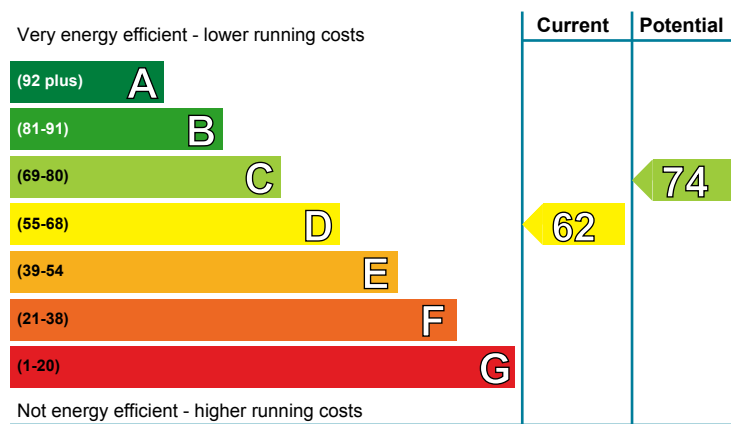
Energy Efficiency Rating

This graph shows the current efficiency of your home, taking into account both energy efficiency and fuel costs. The higher this rating, the lower your fuel bills are likely to be.

Your current rating is **band D (62)**. The average rating for EPCs in Scotland is **band D (61)**.

The potential rating shows the effect of undertaking all of the improvement measures listed within your recommendations report.

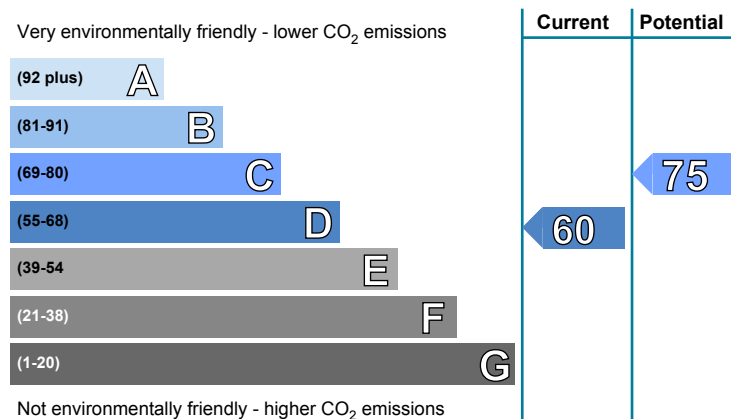
Environmental Impact (CO₂) Rating

This graph shows the effect of your home on the environment in terms of carbon dioxide (CO₂) emissions. The higher the rating, the less impact it has on the environment.
