Home Report

Single Survey

Property address	11 Norbreck Drive Giffnock Glasgow G46 6AF
-------------------------	---

Prepared by	Shepherd Chartered Surveyors
--------------------	------------------------------

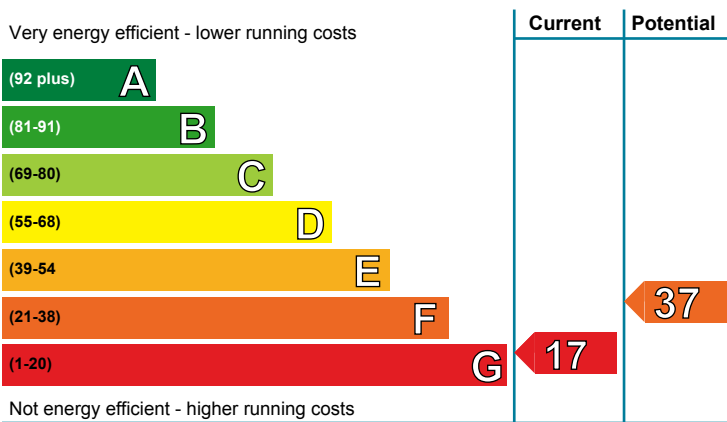
Energy Efficiency Rating

This graph shows the current efficiency of your home, taking into account both energy efficiency and fuel costs. The higher this rating, the lower your fuel bills are likely to be.

Your current rating is **band G (17)**. The average rating for EPCs in Scotland is **band D (61)**.

The potential rating shows the effect of undertaking all of the improvement measures listed within your recommendations report.

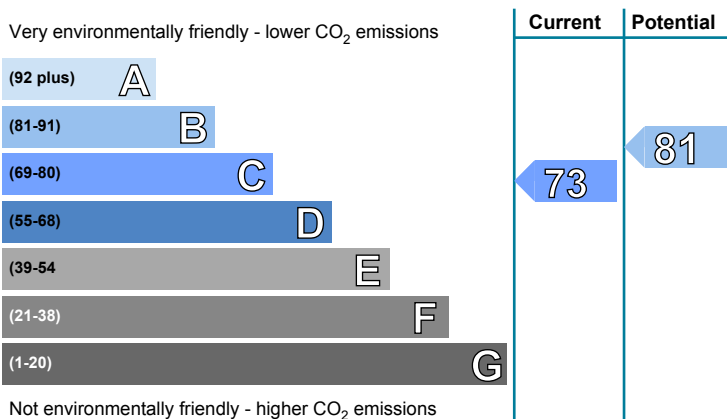
Environmental Impact (CO₂) Rating

This graph shows the effect of your home on the environment in terms of carbon dioxide (CO₂) emissions. The higher the rating, the less impact it has on the environment.
