2/6 27 Broomhill Avenue,
Broomhill,
Glasgow,
G11 7BF

Home Report

Single Survey

Property Address	2/6 27 Broomhill Avenue, Broomhill, Glasgow, G11 7BF
Reference	1626292
Customer Name	Ryan Metcalfe
Date of Inspection	11th June 2026
Surveyor's name, qualifications and office	Paul Reilly BSc, MRICS DM Hall LLP Chartered Surveyors 3 Centura Court, Hillington Park Glasgow G52 4PR Tel: 0141 636 4141 email: glasgowresidential@dmhall.co.uk
Prepared By	DM Hall LLP

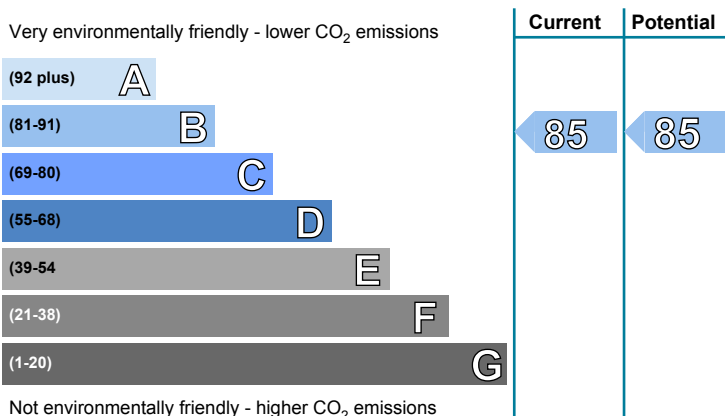
Environmental Impact (CO₂) Rating

This graph shows the effect of your home on the environment in terms of carbon dioxide (CO₂) emissions. The higher the rating, the less impact it has on the environment.
