Home Report

Single Survey

Property address	199 Templehill Troon KA10 6BH
-------------------------	-------------------------------------

Prepared by	Shepherd Chartered Surveyors
--------------------	------------------------------

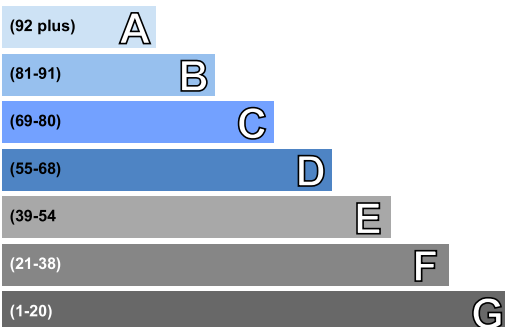
Environmental Impact (CO₂) Rating

Very environmentally friendly - lower CO₂ emissions

Current	Potential
69	81
