YOUR ONESURVEY
HOME REPORT

7 Dundonald Crescent
Newton Mearns
Glasgow
G77 5TJ

SINGLE SURVEY

Single Survey

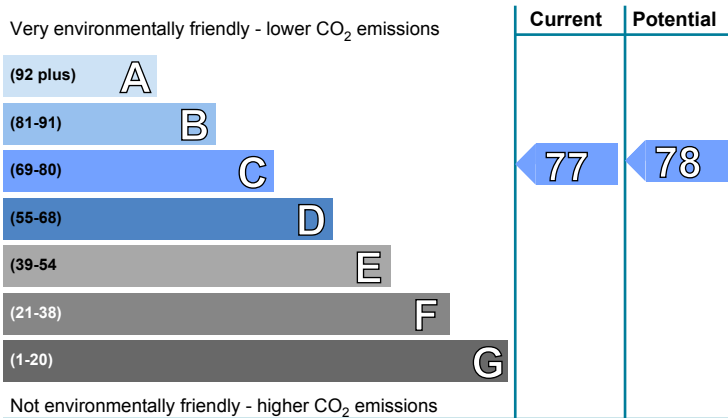
Environmental Impact (CO₂) Rating

This graph shows the effect of your home on the environment in terms of carbon dioxide (CO₂) emissions. The higher the rating, the less impact it has on the environment.
