Home Report

15b Gogo Street,
LARGS,
KA30 8BU

Single Survey

Property Address	15b Gogo Street, LARGS, KA30 8BU
Reference	1628233
Customer Name	Ross Harper
Date of Inspection	16th June 2026
Surveyor's name, qualifications and office	Greg Fisher BSc (hons) MSc MRICS DM Hall LLP Chartered Surveyors ' Eldo House, Monkton Road, Prestwick, KA9 2PB Tel: 01292 286974 email: ayrshireresidential@dmhall.co.uk
Prepared By	DM Hall LLP

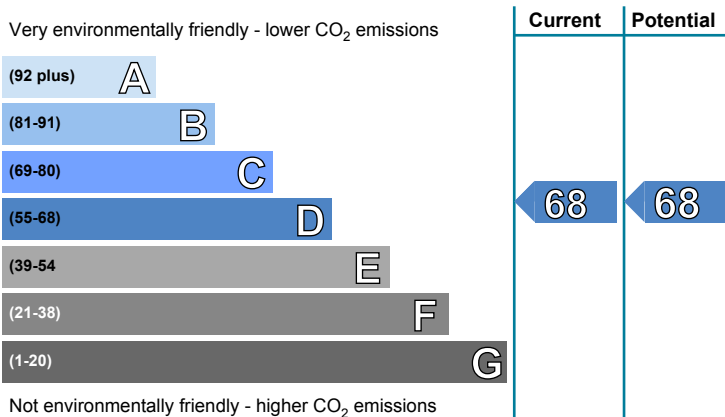
Environmental Impact (CO₂) Rating

This graph shows the effect of your home on the environment in terms of carbon dioxide (CO₂) emissions. The higher the rating, the less impact it has on the environment.
