YOUR ONESURVEY
HOME REPORT

Flat 0/2
2 John Neilson Avenue
Paisley
PA1 2SR

SINGLE SURVEY

Single Survey

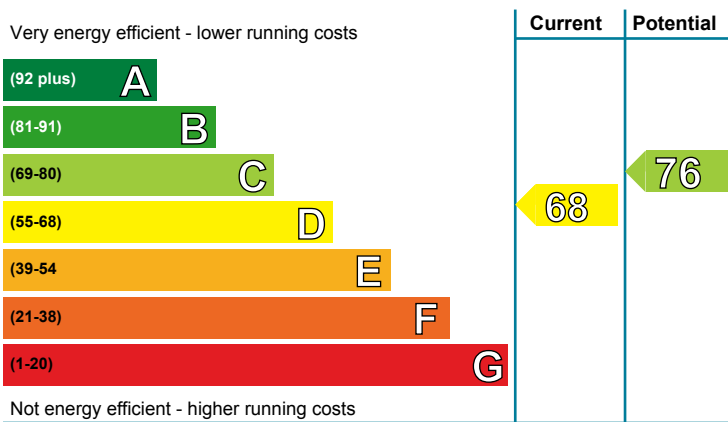
Energy Efficiency Rating

This graph shows the current efficiency of your home, taking into account both energy efficiency and fuel costs. The higher this rating, the lower your fuel bills are likely to be.

Your current rating is **band D (68)**. The average rating for EPCs in Scotland is **band D (61)**.

The potential rating shows the effect of undertaking all of the improvement measures listed within your recommendations report.
