YOUR ONESURVEY
HOME REPORT

123 Seedhill Road
Paisley
PA1 1RD

SINGLE SURVEY

Single Survey

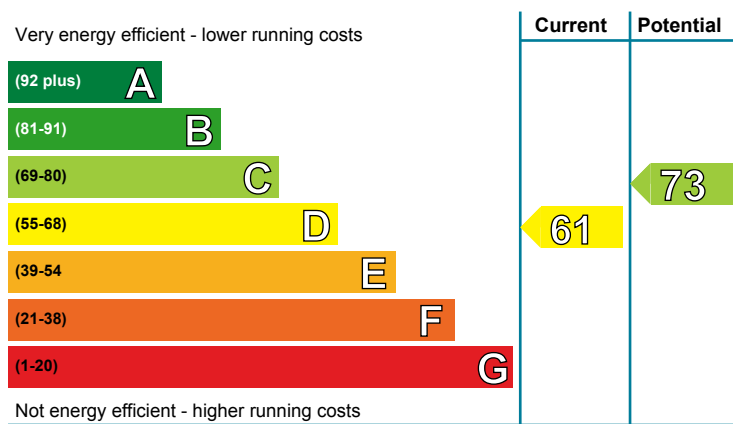
Energy Efficiency Rating

This graph shows the current efficiency of your home, taking into account both energy efficiency and fuel costs. The higher this rating, the lower your fuel bills are likely to be.

Your current rating is **band D (61)**. The average rating for EPCs in Scotland is **band D (61)**.

The potential rating shows the effect of undertaking all of the improvement measures listed within your recommendations report.

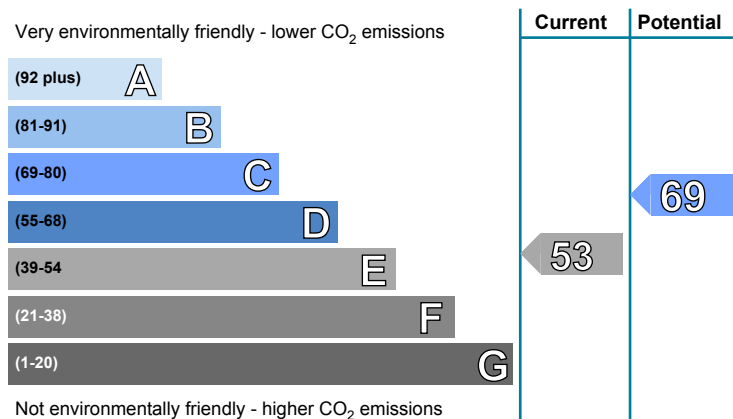
Environmental Impact (CO₂) Rating

This graph shows the effect of your home on the environment in terms of carbon dioxide (CO₂) emissions. The higher the rating, the less impact it has on the environment.
