Home Report

Scottish Single Survey

Property address	9 Stamperland Crescent Clarkston Glasgow G76 8LQ
-------------------------	---

PART 1 - GENERAL

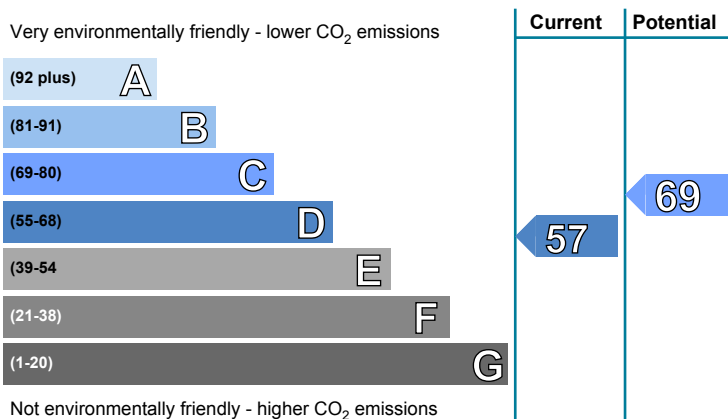
Environmental Impact (CO₂) Rating

This graph shows the effect of your home on the environment in terms of carbon dioxide (CO₂) emissions. The higher the rating, the less impact it has on the environment.
