YOUR ONESURVEY
HOME REPORT

9 Dowanside Road
Dowanhill
Glasgow
G12 9YB

SINGLE SURVEY

Single Survey

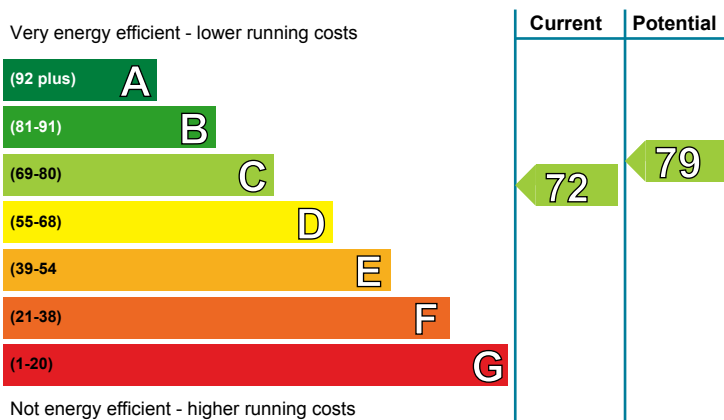
Energy Efficiency Rating

This graph shows the current efficiency of your home, taking into account both energy efficiency and fuel costs. The higher this rating, the lower your fuel bills are likely to be.

Your current rating is **band C (72)**. The average rating for EPCs in Scotland is **band D (61)**.

The potential rating shows the effect of undertaking all of the improvement measures listed within your recommendations report.

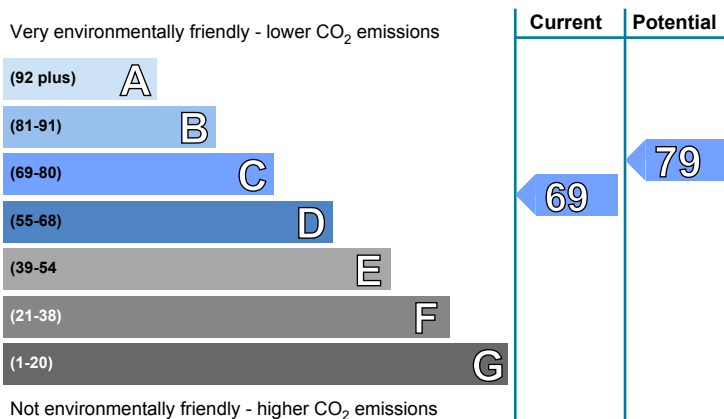
Environmental Impact (CO₂) Rating

This graph shows the effect of your home on the environment in terms of carbon dioxide (CO₂) emissions. The higher the rating, the less impact it has on the environment.
