31 Curlinghall,
LARGS,
KA30 8LB

Home Report

Single Survey

| Property Address | 31 Curlinghall, LARGS, KA30 8LB |

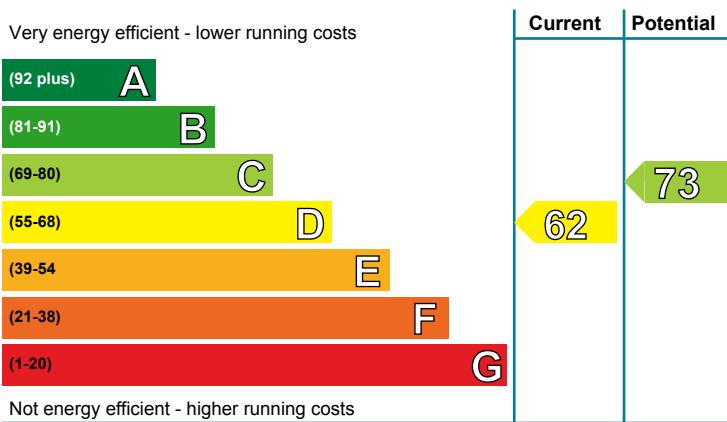
Energy Efficiency Rating

This graph shows the current efficiency of your home, taking into account both energy efficiency and fuel costs. The higher this rating, the lower your fuel bills are likely to be.

Your current rating is **band D (62)**. The average rating for EPCs in Scotland is **band D (61)**.

The potential rating shows the effect of undertaking all of the improvement measures listed within your recommendations report.
