Home Report

Scottish Single Survey

Single Survey

Property address	4 Welltrees Street Maybole KA19 7AW
Customer	Mr G Faulds
Customer address	4 Welltrees Street Maybole KA19 7AW
Prepared by	Shepherd Chartered Surveyors
Date of inspection	02/06/2026

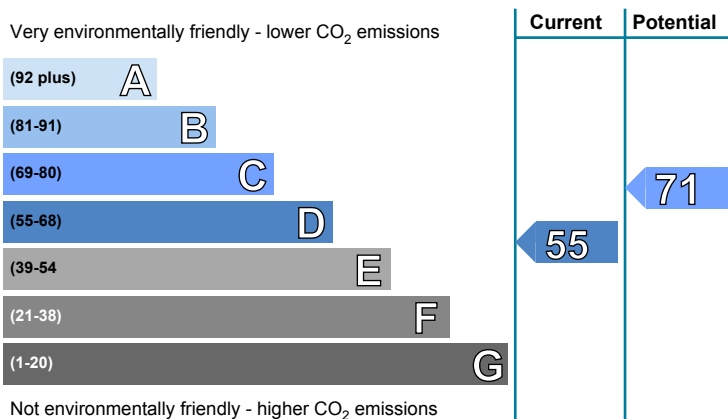
Environmental Impact (CO₂) Rating

This graph shows the effect of your home on the environment in terms of carbon dioxide (CO₂) emissions. The higher the rating, the less impact it has on the environment.
