# Home Report

# Single Survey

<b>Property address</b>	2/1 71 Cartvale Road Glasgow G42 9RP
<b>Customer</b>	Calum MacLennan
<b>Customer address</b>	2/1 71 Cartvale Road Glasgow G42 9RP
<b>Prepared by</b>	Shepherd Chartered Surveyors
<b>Date of inspection</b>	06/07/2026

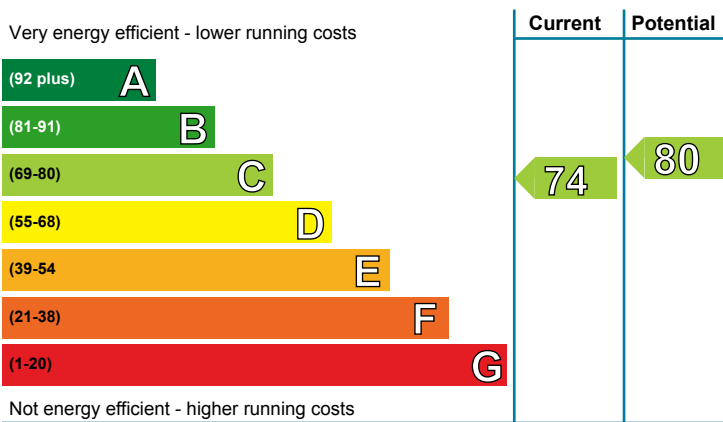
## Energy Efficiency Rating

This graph shows the current efficiency of your home, taking into account both energy efficiency and fuel costs. The higher this rating, the lower your fuel bills are likely to be.

Your current rating is **band C (74)**. The average rating for EPCs in Scotland is **band D (61)**.

The potential rating shows the effect of undertaking all of the improvement measures listed within your recommendations report.

<b>Estimated energy costs for your home for 3 years*</b>	<b>£2,904</b>	See your recommendations report for more information
<b>Over 3 years you could save*</b>	<b>£792</b>

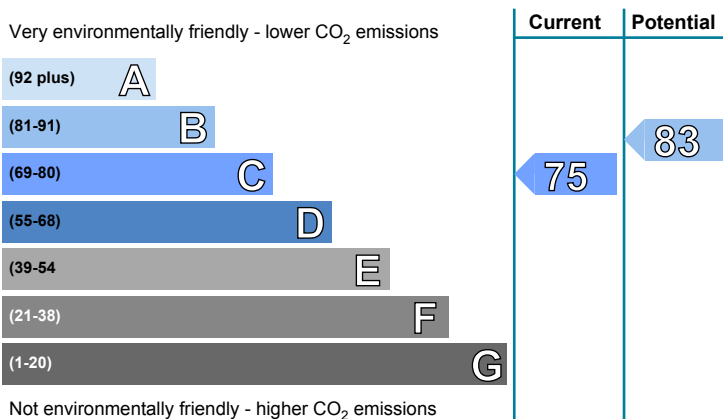
## Environmental Impact (CO<sub>2</sub>) Rating

This graph shows the effect of your home on the environment in terms of carbon dioxide (CO<sub>2</sub>) emissions. The higher the rating, the less impact it has on the environment.
