# Home Report

24 Stewart Avenue,  
Ochiltree,  
KA18 2PR

## Survey Report on:

| <b>Property Address</b> | 24 Stewart Avenue,<br>Ochiltree,<br>KA18 2PR |

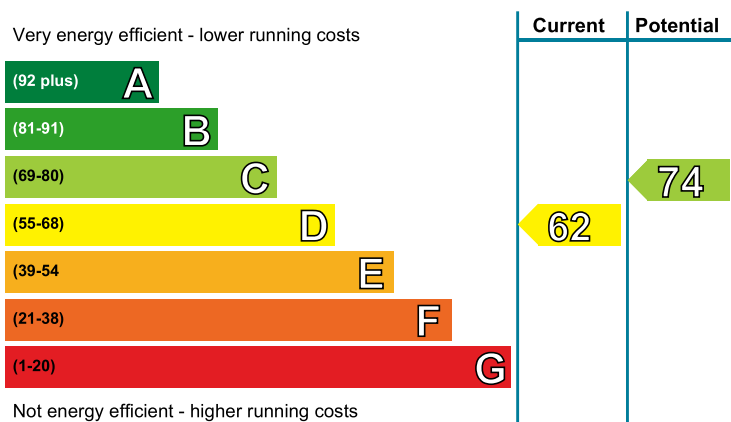
## Energy Efficiency Rating

This graph shows the current efficiency of your home, taking into account both energy efficiency and fuel costs. The higher this rating, the lower your fuel bills are likely to be.

The potential rating shows the effect of undertaking all of the improvement measures listed within your recommendations report.

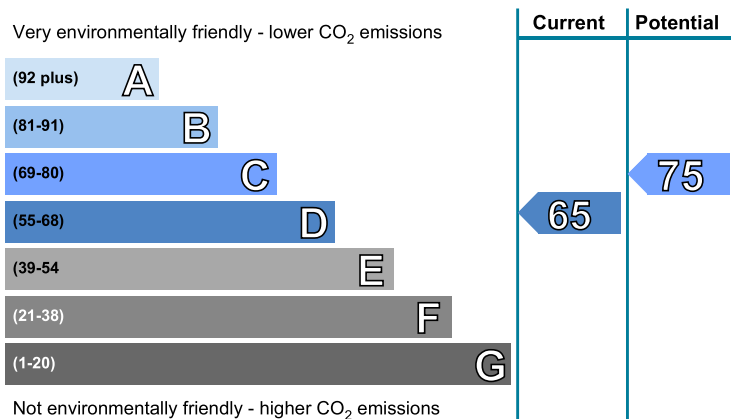
## Environmental Impact (CO<sub>2</sub>) Rating

This graph shows the effect of your home on the environment in terms of carbon dioxide (CO<sub>2</sub>) emissions. The higher the rating, the less impact it has on the environment.
