# Home Report

# Single Survey

| Property address | 30 Woodside Avenue<br>Thornliebank<br>Glasgow<br>G46 7HR |
| Prepared by | Shepherd Chartered Surveyors |

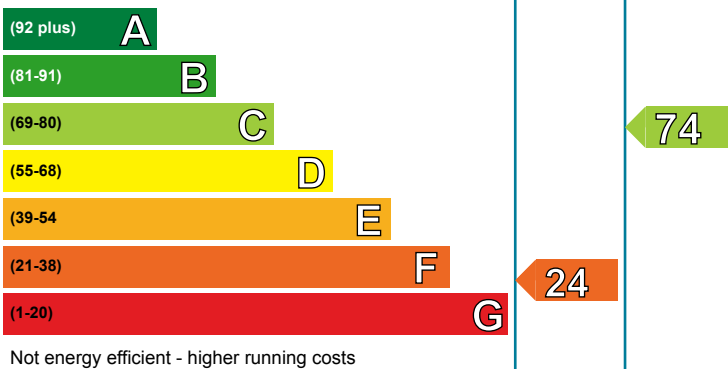
## Energy Efficiency Rating

This graph shows the current efficiency of your home, taking into account both energy efficiency and fuel costs. The higher this rating, the lower your fuel bills are likely to be.

The potential rating shows the effect of undertaking all of the improvement measures listed within your recommendations report.

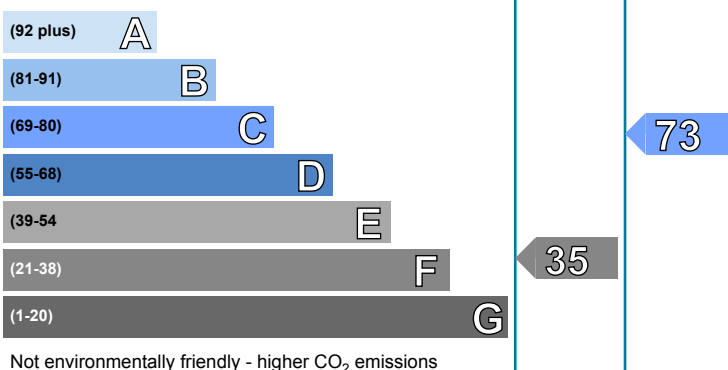
## Environmental Impact (CO<sub>2</sub>) Rating

This graph shows the effect of your home on the environment in terms of carbon dioxide (CO<sub>2</sub>) emissions. The higher the rating, the less impact it has on the environment.
