# Home Report

# Scottish Single Survey

| Property address | 0/1<br>94 Portland Street<br>Troon<br>KA10 6QN |
| Prepared by | Shepherd Chartered Surveyors |

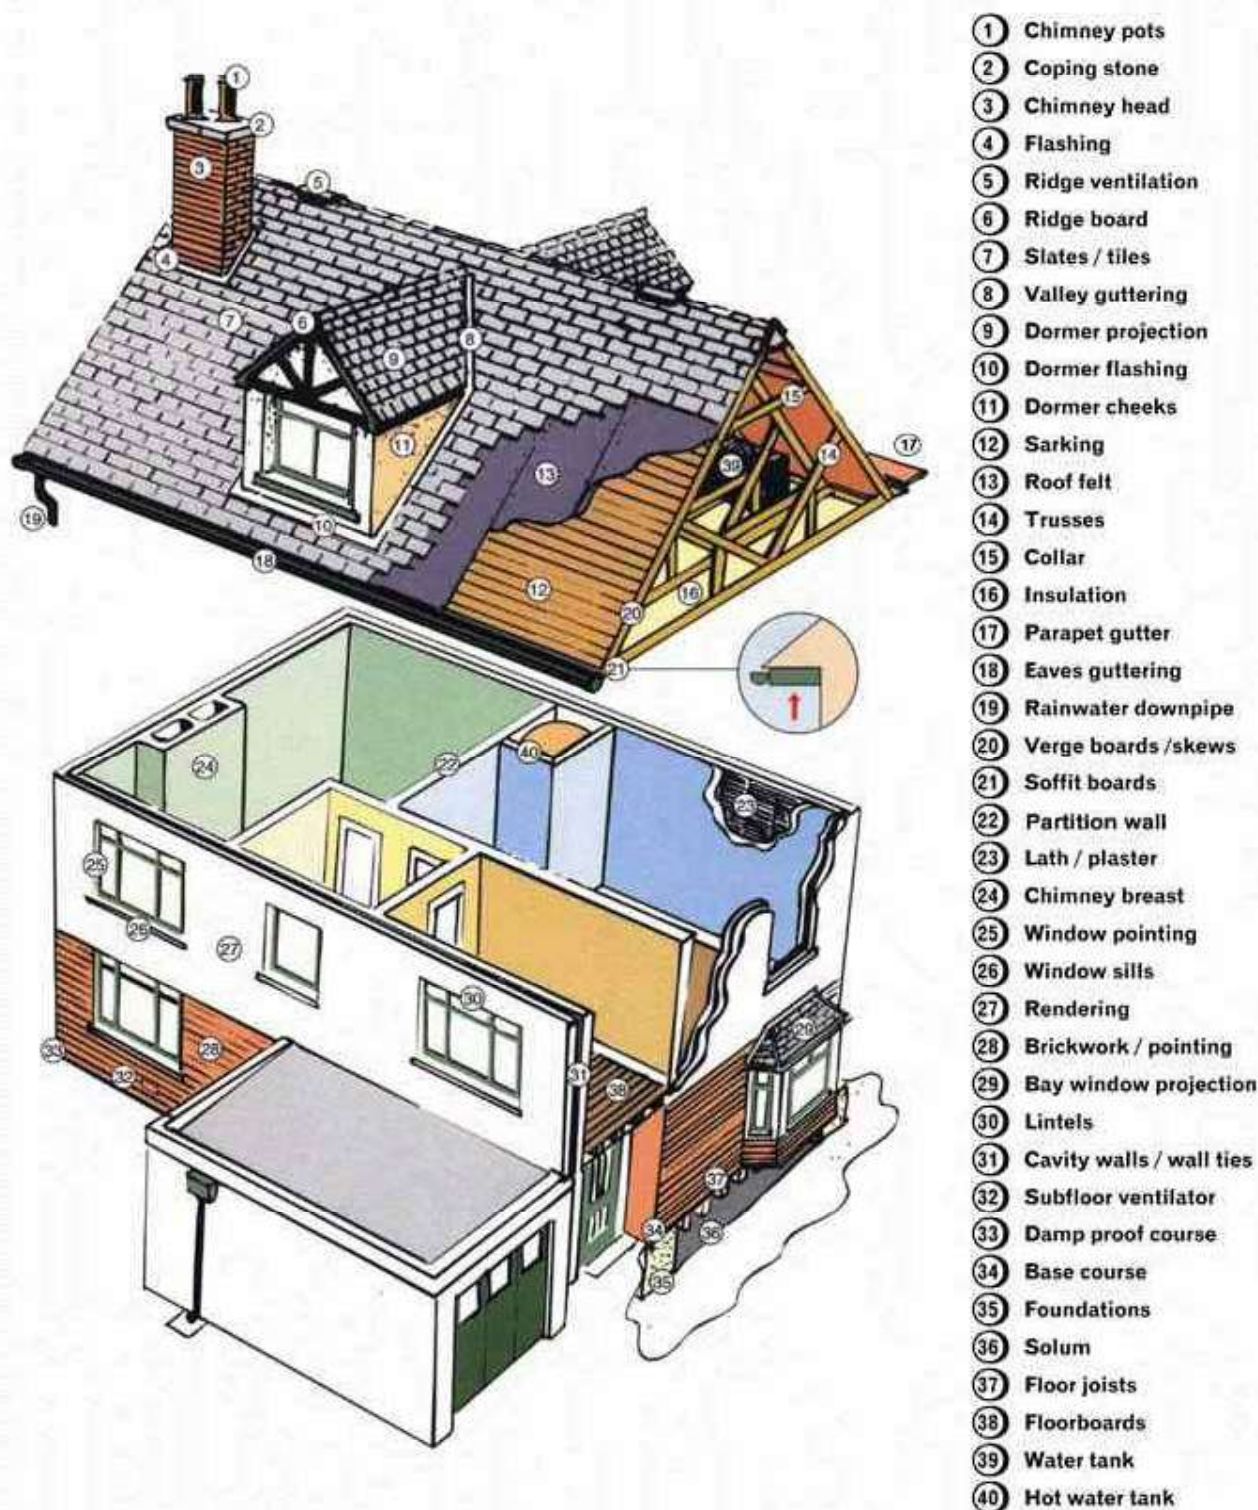
## Sectional Diagram showing elements of a typical house

Reference may be made in this report to some or all of the above component parts of the property. This diagram may assist you in locating and understanding these items.
