# Home Report

# Scottish Single Survey

| Property address | 15 Dirleton Gate<br>Bearsden<br>Glasgow<br>G61 1NP |
| Prepared by | Shepherd Chartered Surveyors |

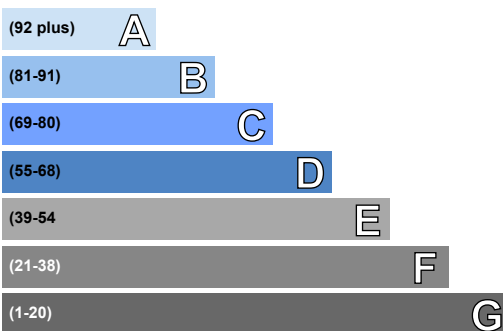
Very environmentally friendly - lower CO<sub>2</sub> emissions

| Current | Potential |
| 66 | 73 |
