# Home Report

# Scottish Single Survey

| Property address | 2 Beech Cottage<br>North Street<br>Houston<br>Johnstone<br>PA6 7HF |
| Prepared by | Shepherd Chartered Surveyors |

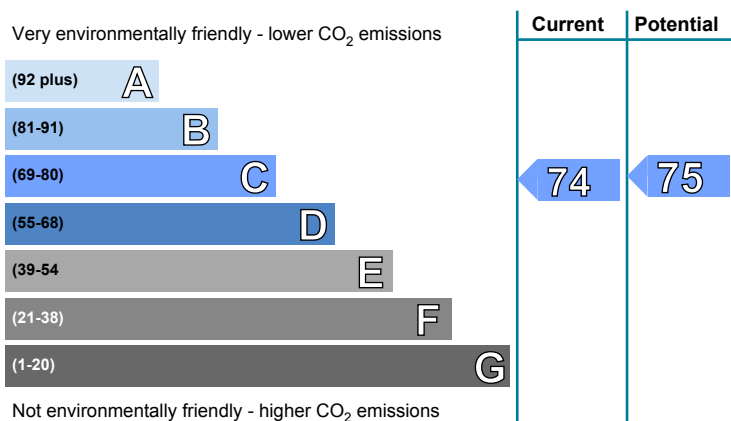
## Environmental Impact (CO<sub>2</sub>) Rating

This graph shows the effect of your home on the environment in terms of carbon dioxide (CO<sub>2</sub>) emissions. The higher the rating, the less impact it has on the environment.
