# Home Report

Flat 58,  
1,  
Sanderling View,  
Barassie Street,  
Troon,  
KA10 6LU

# Single Survey

## Survey Report on:

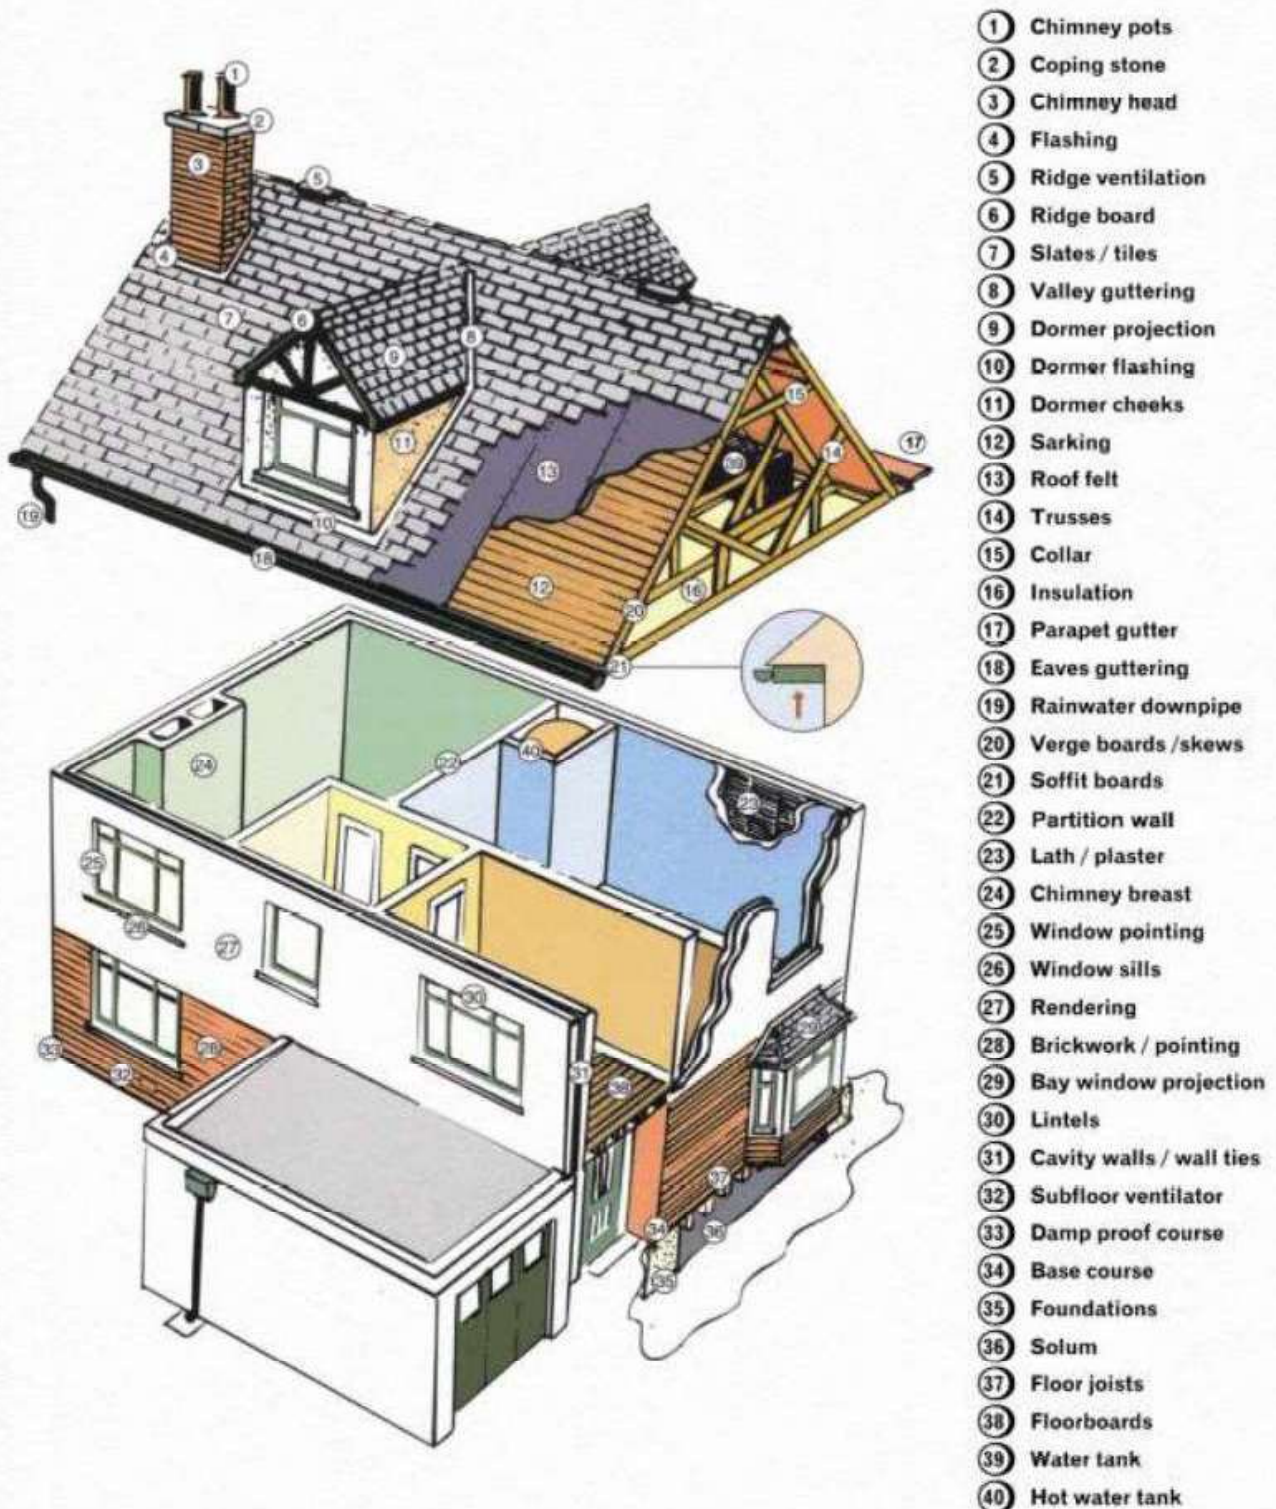
## Sectional Diagram showing elements of a typical house

Reference may be made in this report to some or all of the above component parts of the property. This diagram may assist you in locating and understanding these items.

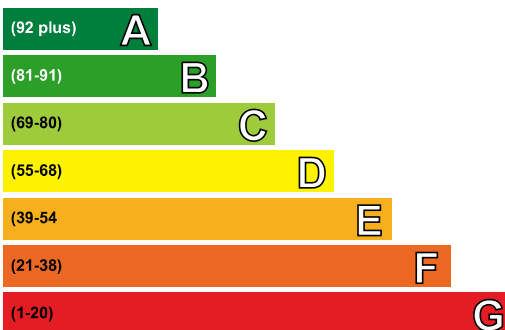
Very energy efficient - lower running costs

Not energy efficient - higher running costs

The potential rating shows the effect of undertaking all of the improvement measures listed within your recommendations report.

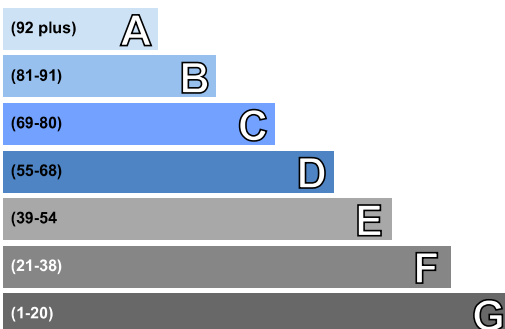
Very environmentally friendly - lower CO<sub>2</sub> emissions

Not environmentally friendly - higher CO<sub>2</sub> emissions
