# Home Report

25 Dublin Quay,  
Irvine,  
KA12 8PQ

## Survey Report on:

| <b>Property Address</b> | 25 Dublin Quay,<br>Irvine,<br>KA12 8PQ |

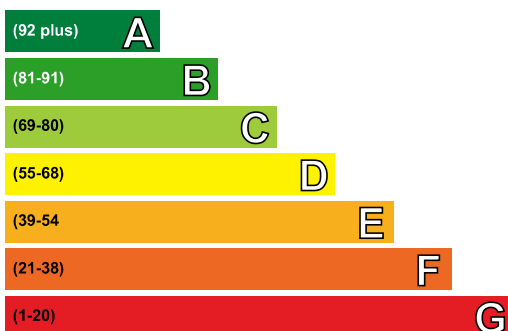
Very energy efficient - lower running costs

Not energy efficient - higher running costs

The potential rating shows the effect of undertaking all of the improvement measures listed within your recommendations report.

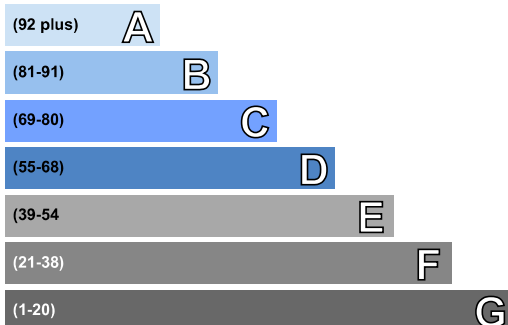
Very environmentally friendly - lower CO<sub>2</sub> emissions

Not environmentally friendly - higher CO<sub>2</sub> emissions
